# CAPITAL IMPROVEMENT PLAN FOR THE

SEPTEMBER 2011

**Village of Barker  
Capital Improvement Plan  
September 2011**

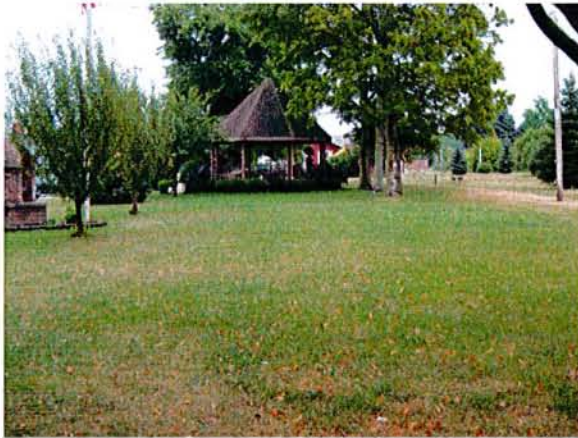
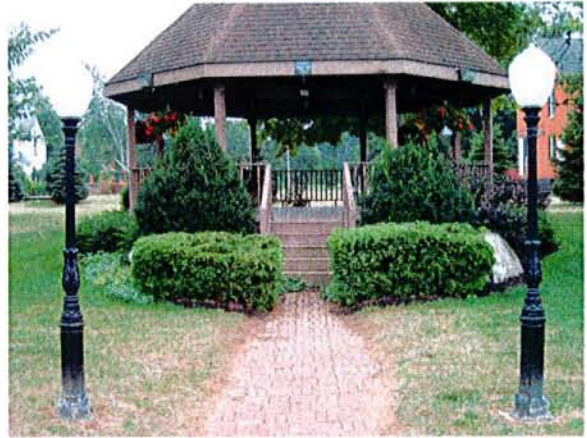
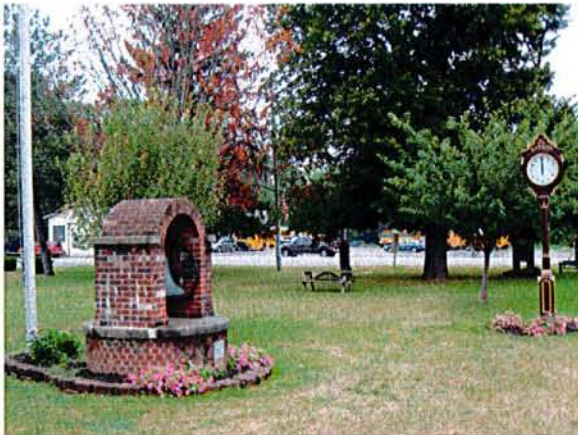
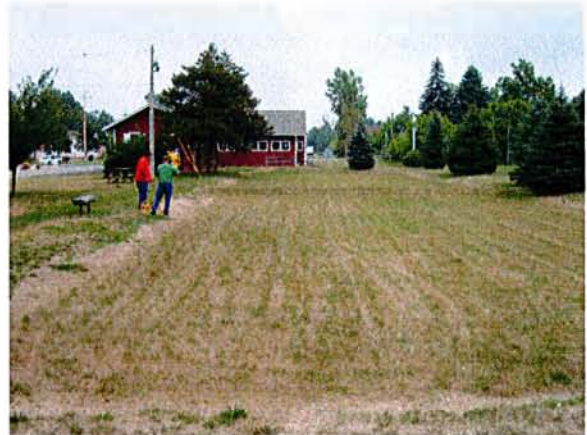
**Village Park**

Gazebo in need of handicap access  
Ice Rink area to be paved for summer basketball use

- Improvements to the skating area at Village Park would allow basketball to be played in the summer months. *(Also a Village Board Recommendation)*
- The Village Park gazebo needs to be made handicap accessible.
- The electrical service breaker box should be replaced at the Village Park gazebo.
- Broken granite curbing in front of Village Park should be repaired.
- At Barker Bicentennial Park, shoreline erosion protection should be evaluated by a qualified marine engineer, and necessary improvements implemented. *(Also a Village Board Recommendation)*
- At Barker Bicentennial Park, "sink holes" need to be repaired. *(Also a Village Board Recommendation)*

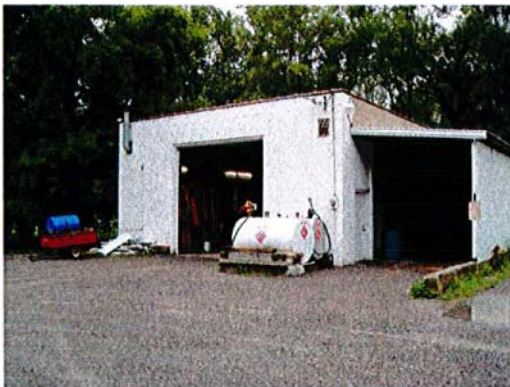
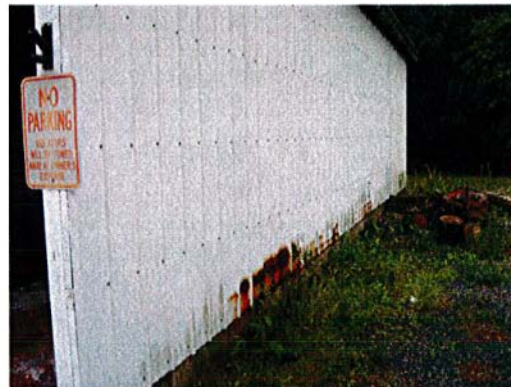
Salt storage facility in need of rehabilitation

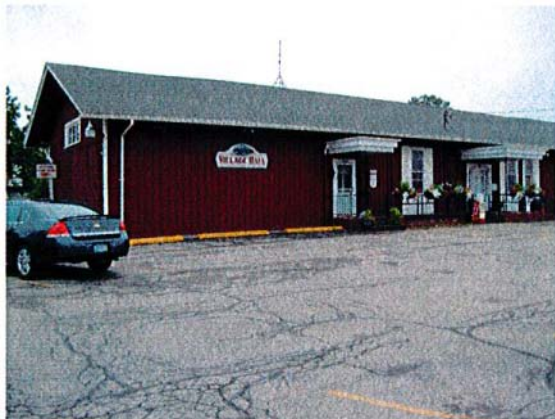
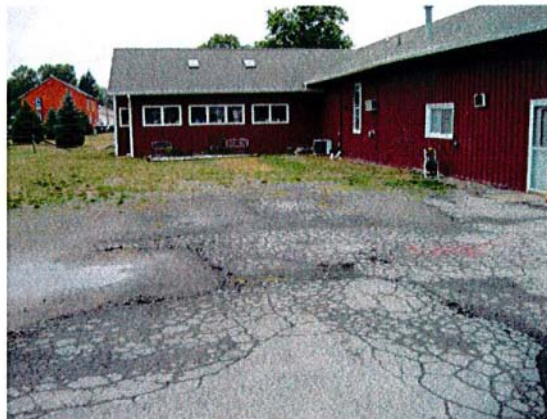
Village Hall Building & Rear side view showing need for parking improvements.

- The existing electrical service to Village Hall is 100 amps. Although considered adequate at this time, some consideration should be given to increasing the service capacity, if necessary.
- The pavement in the parking area in front of the building is in fair to poor condition. This area should be top-coated and striped to prevent further deterioration.
- Consideration should be given to paving the approximate 50' by 60' area directly behind the Village Hall portion of the building.
- Presently, the Village Hall does not have stand-by power for activation during a storm-related or other emergency. Consideration should be given installing a permanent emergency generator so that normal Village Office, Barker Police Department, and Barker Free Library operations can be conducted during an extended power outage.

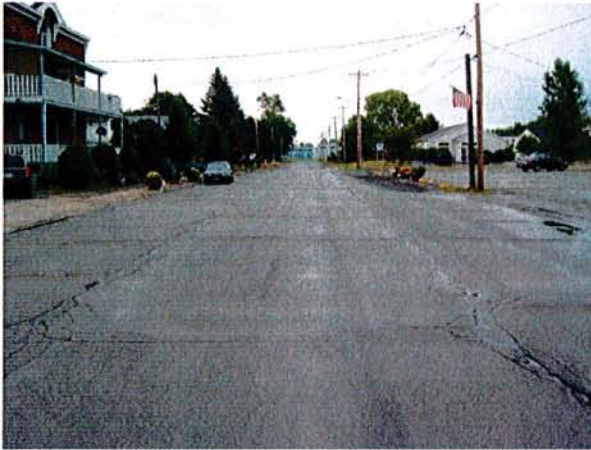
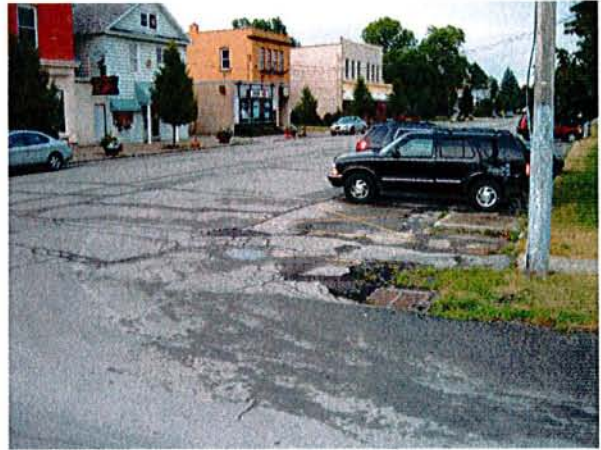
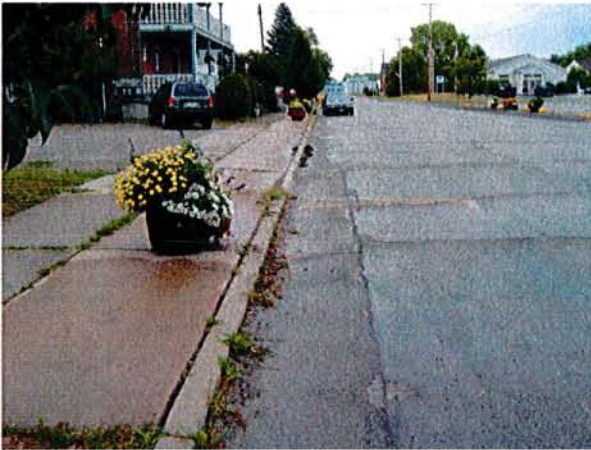
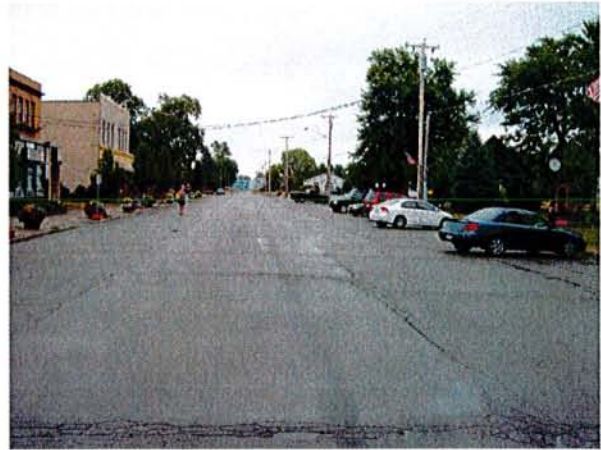
Main Street was found to have moderate traffic volume, fair to poor pavement, and drainage in significant need of improvement. The entire length of Main Street between Quaker Road and East Avenue exhibits extensive cracking and uneven grading. If this section of Main Street were to be repaved, however, it would be best to mill and resurface the area since the concrete curbing located on the north side of the roadway has only about 2" of reveal. There is granite curbing on the south side of the roadway with approximately 4" of reveal. No curbing or gutters exist between Pallister and East Avenues.

Easterly views of Main Street near intersection of Quaker Road showing uneven pavement, cracking, and curb and drainage deficiencies.

Main Street – Due to its high visibility, high vehicle and pedestrian use, all in conjunction with some easily observed pavement and surface deficiencies; Main Street remains one of the Village's top priorities for improvement. Recommended improvements from the 2005 CIP, and further supported by 2011 observations include: milling and resurfacing of pavement between Quaker Road and East Avenue; new storm sewer piping between Quaker Road and East Avenue; new concrete curbing from Pallister to East Avenues; and new 4' concrete sidewalks along the south side of Main Street in front of Village Park and between Pallister and East Avenues.

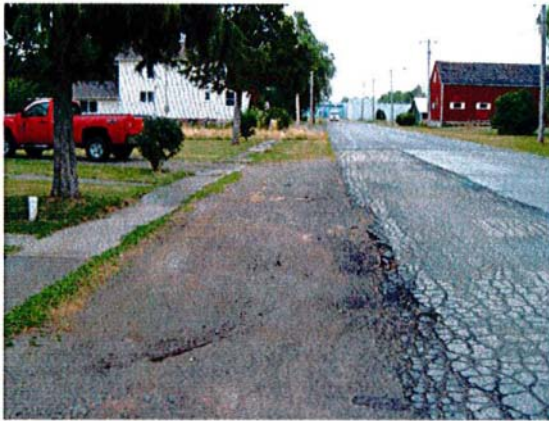
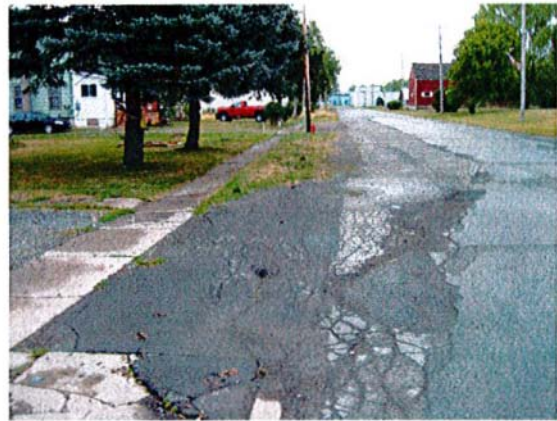
Main Street – Approximately one half of Main Street appears to have a storm sewer system. Smoke testing indicated that several sections have, or discharge to, crushed, broken, or plugged storm sewers. During heavy rainfall events, the area of Main Street at the intersection of East Avenue routinely fills with several inches of water. No curbs or gutters are present on Main Street between East and Pallister Avenues. Between Pallister Avenue and Quaker Road there are, however, granite curbs with 4" reveal on the south and concrete curbs with approximately 2" reveal on the north sides of Main Street.

North side of Main Street near Pallister showing broken, uneven pavement sections, lack of curbing and insufficient drainage.

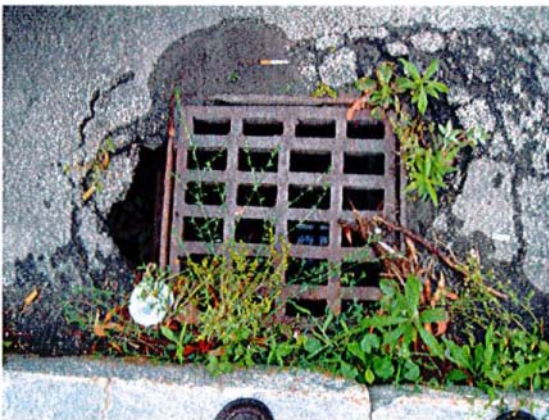
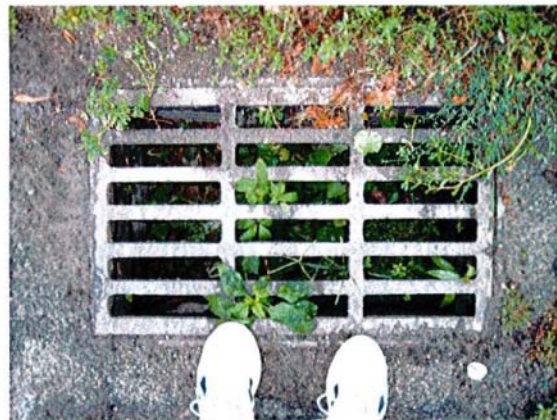
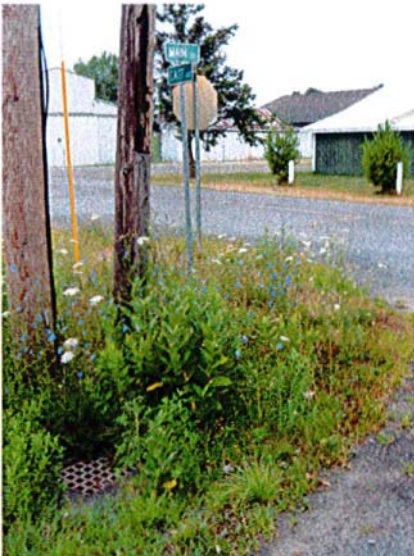
Broken catch basins along Main Street in front of Village Park, HSBC Bank and corner of East Avenue serving for ineffective drainage and difficulty of maintenance.

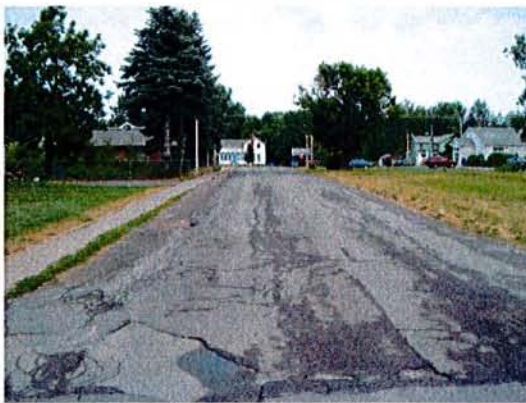
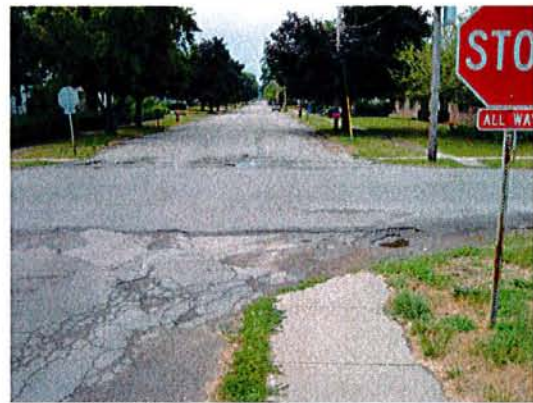
Pallister Avenue was found to have low to moderate traffic volume, good to fair pavement conditions, and drainage in need of significant improvement. A few sections of the roadway between Coleman Road and Church Street appear to have curbing; however, there is no reveal left on the curb line. The catch basins along this area have large drops adjacent to the roadway and are a dangerous situation.

Pallister Avenue between Church and Coleman / Poorly situated CB in front of Funeral Home.

Pallister Avenue – In 2005 Pallister Avenue was also determined to have significant need for improvements to pavement roadway facilities. Based on the identification of these needs the Village performed repaving of the street from Coleman Road to the southern dead end. Although these surface improvements will suffice over the short term, it is still recommended that the following items remain within the capital improvement recommendations: milling and

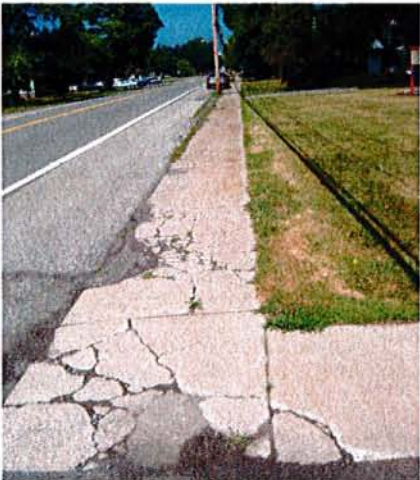
Badly cracked sidewalk on Quaker near High St / High St viewing east from Quaker.

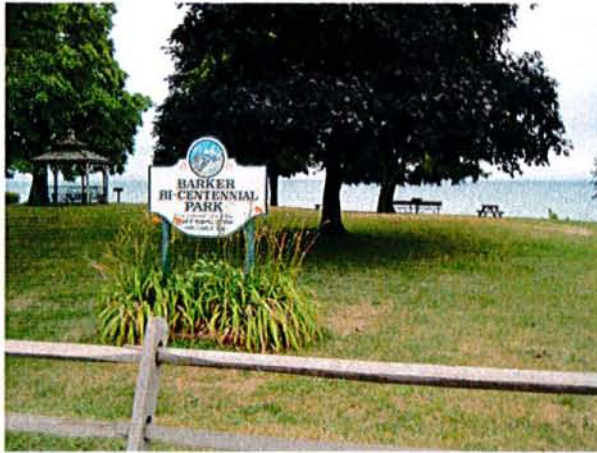
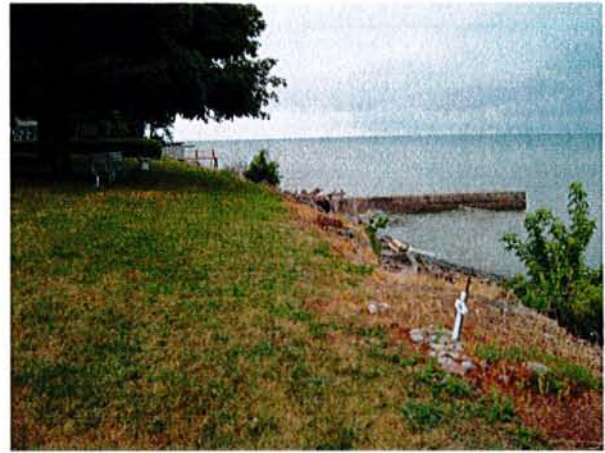
### **Barker Bi-Centennial Park**

Beach and embankment area in need of evaluation and likely design of shoreline erosion protection features.
