LaSalle Park Design and Waterfront Access

Schematic Plan

LASALLE PARK MASTER PLAN UPDATE

PROJECT: LASALLE PARK LAKE RAMP INVESTIGATION, RBCD PROJECT NO.: 11833

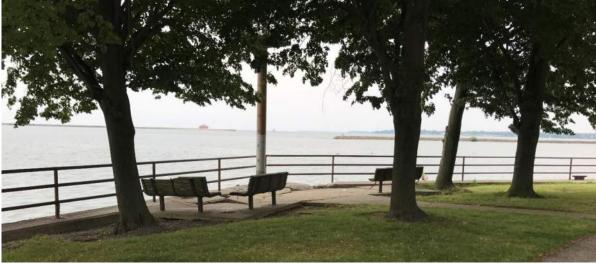
Existing conditions

In the south-west corner of the park there is a small seating area with four benches. The pavements in this area are unsafe, the benches are damaged, and the seawall exhibits surface deterioration.

It is recommended to renovate this area and begin to develop a "node" as depicted in the preferred concept and schematic plans.

- Removal of the pavements, benches and one damaged tree.
- Parging of the seawall.
- Excavating the area where settling has occurred (pneumatic excavation adjacent to
 existing tree roots) and installing an underdrain system to convey water to the existing
 storm system. Installing a geotextile membrane and backfilling with a drainage material.
- Removing and replacing the railing with a compliant railing within the limits of the new construction.
- Constructing new decorative (colored and/or stamped) concrete plaza with benches.

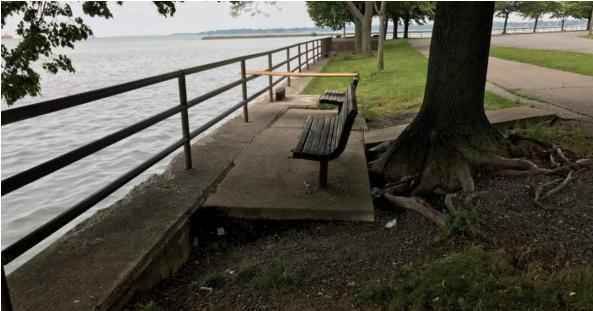
Existing conditions

To the east of the south-west a small seating area exists with two benches. The pavement in this area is unsafe and the benches are damaged.

It is recommended to remove the pavements and benches and reconstruct the seating area approximately 30-feet to the west of its present location, away from the mature tree. In addition to relocating the seating area minor modifications to the existing railing, in front of the benches, would be required to meet compliance.

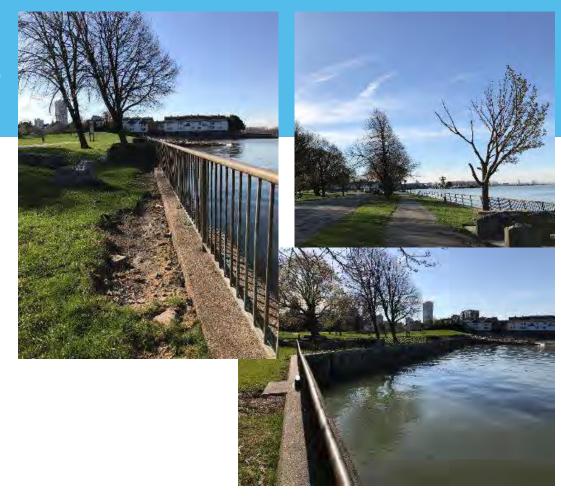
- Railing is adequate as pedestrian access not immediately adjacent
- Benches are functional
- Washouts and sinkholes require filling
- Seaplane ramp topping concrete eroded and structural steel exposed, requires further investigation
- Deposited debris requires maintenance to remove

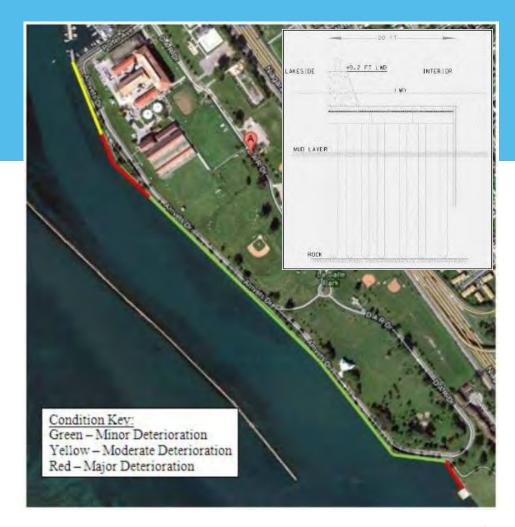
- Majority of seawall within project area was found to have minor deterioration
- Northern portion of wall near pumping station is planned for repair
- Southern portion of wall near seaplane ramp was found to have major deterioration. This area has the most washouts and/or sinkholes that require annual maintenance

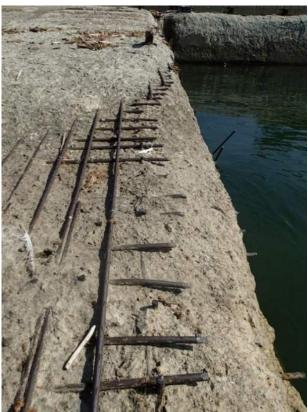
Photograph 6

There is an approximately 10-foot-wide strip of the ramp located approximately 30 feet from the north wall that has no visible top reinforcing running down the length of the ramp (east/west direction). At this location, reinforcing was observed running in the north/south direction across the ramp at approximately 12 inches on-center. See Photograph 7. Every other bar from the mats to the north and south, which were spaced at 6 inches on-center, are discontinued leaving the remaining bars at a 12-inch spacing (see Photograph 8). Vertical bars were observed in this strip and are spaced at roughly 6 inches on-center across the ramp (north/south direction) and 16 inches on-center down the length of the ramp. This could be an indication of a vertical support such as a wall, below the ramp in this area.

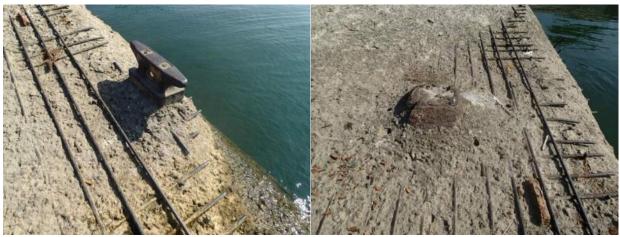
Photograph 11 Photograph 12

A total of four steel cleats were observed; two at the north and two at the south sides of the ramp. Two raised areas of concrete were also observed; one at the north and one at the south side of the ramp. These locations each had four large anchor bolts that appeared to have been cut off. These items were likely anchorages of some kind. See Photographs 11 and 12.

Overall, the ramp as whole appeared to be intact and has not experienced visible settlement or listing.

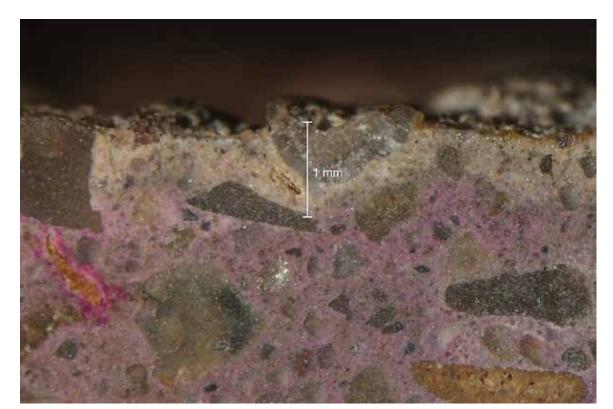
PHOTO: 7

DESCRIPTION: Carbonation (unstained paste) proceeded to a maximum depth of 1 mm (1/32"); on a freshly saw-cut and lapped profile of the core with the top surface oriented up, after application of phenolphthalein pH indicator.

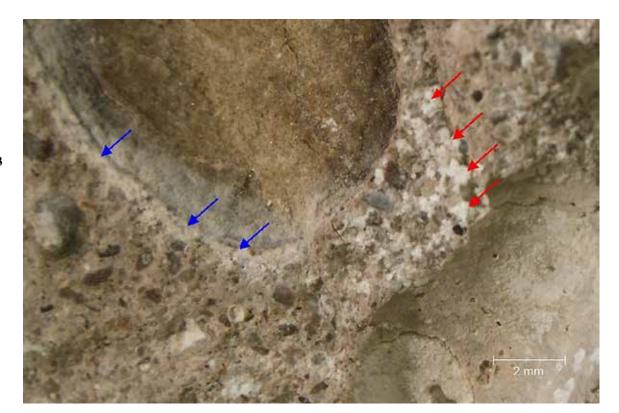
PHOTO: 13

DESCRIPTION: Deposits of white, acicular ettringite (red arrows) and alkali-silica gel (blue arrows) on the fractured bottom surface of the core.
