LaSalle Park Design and Waterfront Access

Schematic Plan

LASALLE PARK MASTER PLAN UPDATE

PROJECT: LASALLE PARK LAKE RAMP INVESTIGATION, RBCD PROJECT NO.: 11833

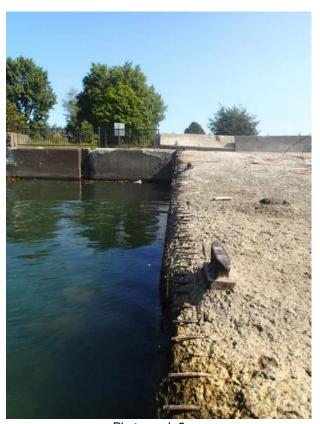
At the north and south walls, the top ends of the vertical reinforcing were visible. This reinforcing appeared to be spaced at 12 inches on-center going down the length of the ramp (east/west direction). There appeared to be three lines of vertical reinforcing bars spaced at approximately 12 inches on-center. The thickness of the wall appeared to be approximately 3 feet. See Photographs 5 and 6.

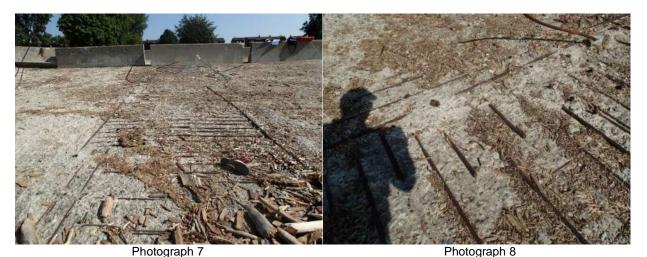
There is an approximately 10-foot-wide strip of the ramp located approximately 30 feet from the north wall that has no visible top reinforcing running down the length of the ramp (east/west direction). At this location, reinforcing was observed running in the north/south direction across the ramp at approximately 12 inches on-center. See Photograph 7. Every other bar from the mats to the north and south, which were spaced at 6 inches on-center, are discontinued leaving the remaining bars at a 12-inch spacing (see Photograph 8). Vertical bars were observed in this strip and are spaced at roughly 6 inches on-center across the ramp (north/south direction) and 16 inches on-center down the length of the ramp. This could be an indication of a vertical support such as a wall, below the ramp in this area.

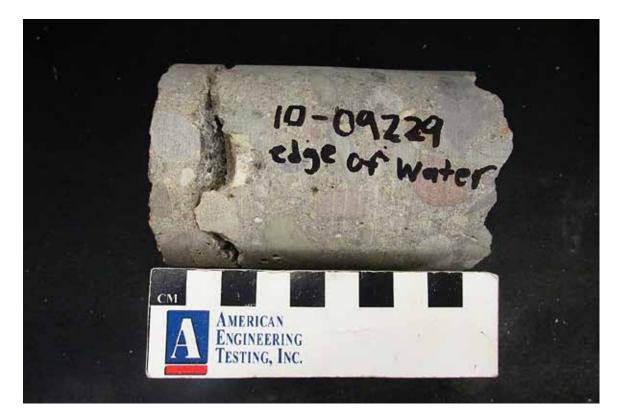
PHOTO: 1

N: The overall profile of the core as received, with the top surface oriented to the left.

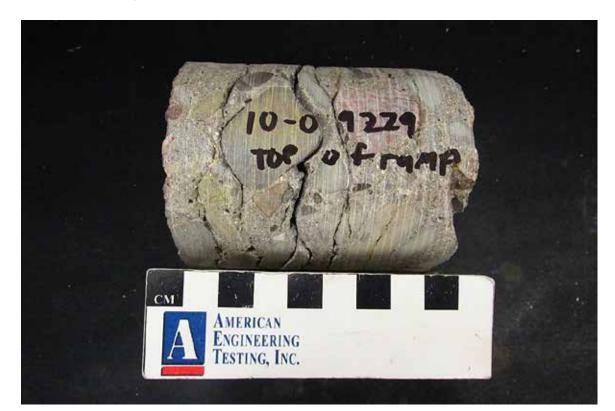
РНОТО: 3

The overall profile of the core as received, with the top surface oriented to the left.

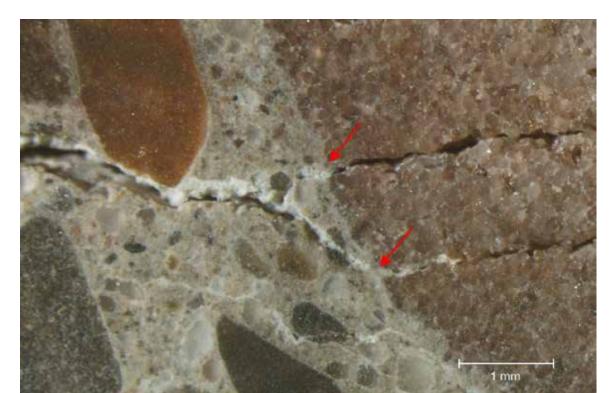
PHOTO: 11

Both cores were cracked horizontally below the concrete surface. APS' report indicates that ASR was present in both cores and contributed to cracking. ASR occurs when aggregates containing certain forms of silica react with alkali hydroxide ions in concrete to form a gel that swells as it absorbs water. As the gel swells it puts pressure on the surrounding concrete, which eventually initiates a crack or a pop-out. APS' report provides magnified images of this gel layer, which will surround the aggregate and fill cracks and other voids in the concrete.

DESCRIPTION: Colorless to white alkali-silica gel partially filling a sub-horizontal micro-crack and forming gel "plugs" (red arrows) at the outer surface of a sandstone coarse aggregate particle (right)

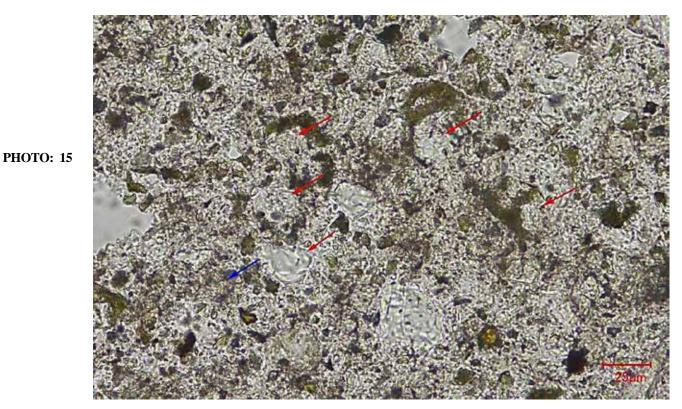
DESCRIPTION: Fully-hydrated alite relicts (red arrows) and well-hydrated residual belite (blue arrow) as portland cement clinker particles in a thin section of concrete, viewed under plane-polarized light.
