**PROPOSED REMEDIAL ACTION PLAN  
BUFFALO LAKESIDE COMMERCE PARK –  
PARCEL 4 SITE**

**Environmental Restoration Project  
Buffalo, Erie County, New York  
Site No. E-9-15-193**

January 2009

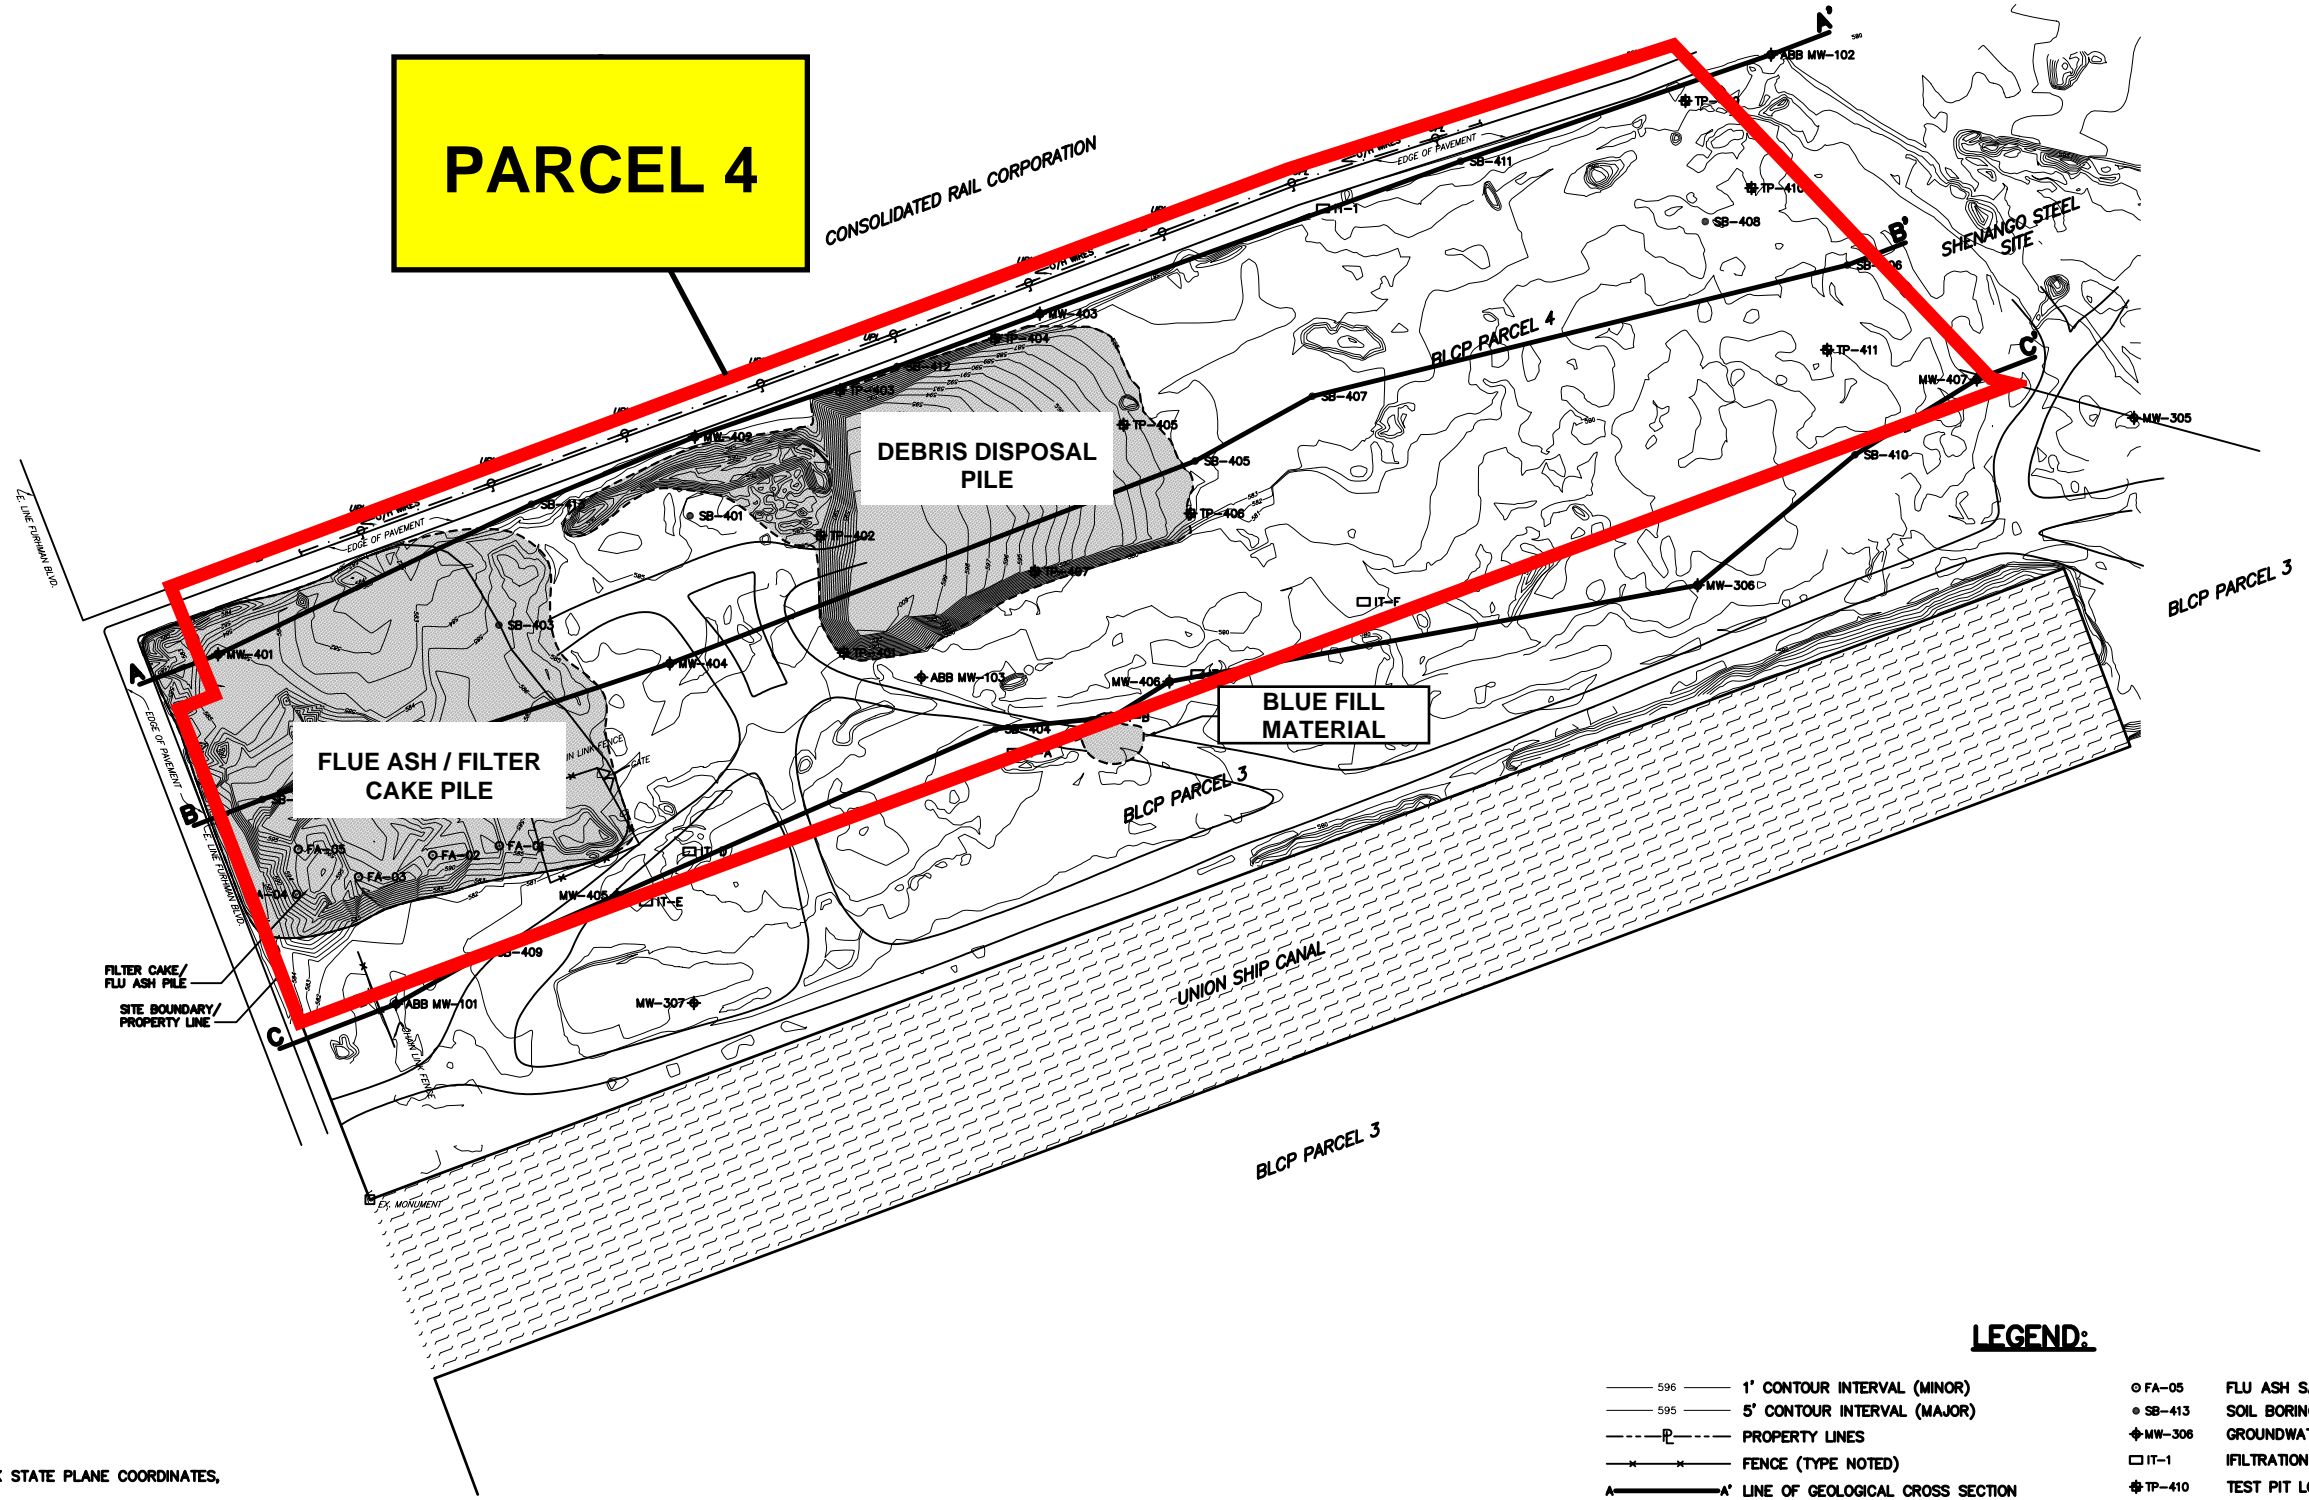
**FIGURE 2  
SITE MAP**

The Site is generally flat with two areas of pronounced fill material in raised fill mounds, see Figure 2. The first mound is located in the approximate center of the Site and is referred to as the “Debris Disposal Pile”. This 3-acre mound is a ramp-like feature that gradually rises to the west to a maximum relief of approximately 20 feet, with a steep western face. The Debris Disposal Pile is composed of native materials including sand, gravel, cobbles and boulders and fill materials including black sand, ash, slag, brick concrete, wire rope (cable), tires, crushed stone, metal debris and various other construction and demolition debris.

The second raised fill area is along the western end of the Site and is called the “Filter Cake/Flue Ash Pile”. This mound of fill is composed entirely of the byproducts from iron production: black fine-grained flue ash, collected from the exhaust of the iron blast furnaces; and filter cake, the solids screened from the wet “scrubbers” which separated impurities from the same furnace exhaust before the combustible gases were recycled back to the furnaces. The surface of the 3.7-acre Filter Cake/Flue Ash (FC/FA) pile is “hummocky”; actually best characterized as several smaller, connected mounds with a maximum height of approximately 15 feet.

**Blue Fill** – A deep blue-colored layer of fill that was encountered during the excavation of one of the infiltration test trenches (IT-B), located near the center of the southern Site property boundary, see Figure 2. The material was composed of wood chips approximately 1/8 inch in size but stained a deep indigo blue color. The composition and color of this fill material indicates that it may be a byproduct of coal gasification from an off-site source. The extent of this material was defined using multiple extended trenches which were subsequently backfilled. This material was sampled for SVOCs, pesticides, PCBs, metals, cyanide, and “free” cyanide (i.e. the more toxic forms of cyanide, not bound or complexed with metals). Analytical results of this sample of blue fill are included on Table 2. One SVOC (dibenzo-a,h-anthracene) and one metal (arsenic) were present at concentrations slightly above SCOs. Cyanide was also present at 918 ppm which is significantly higher than the SCO of 27 ppm.

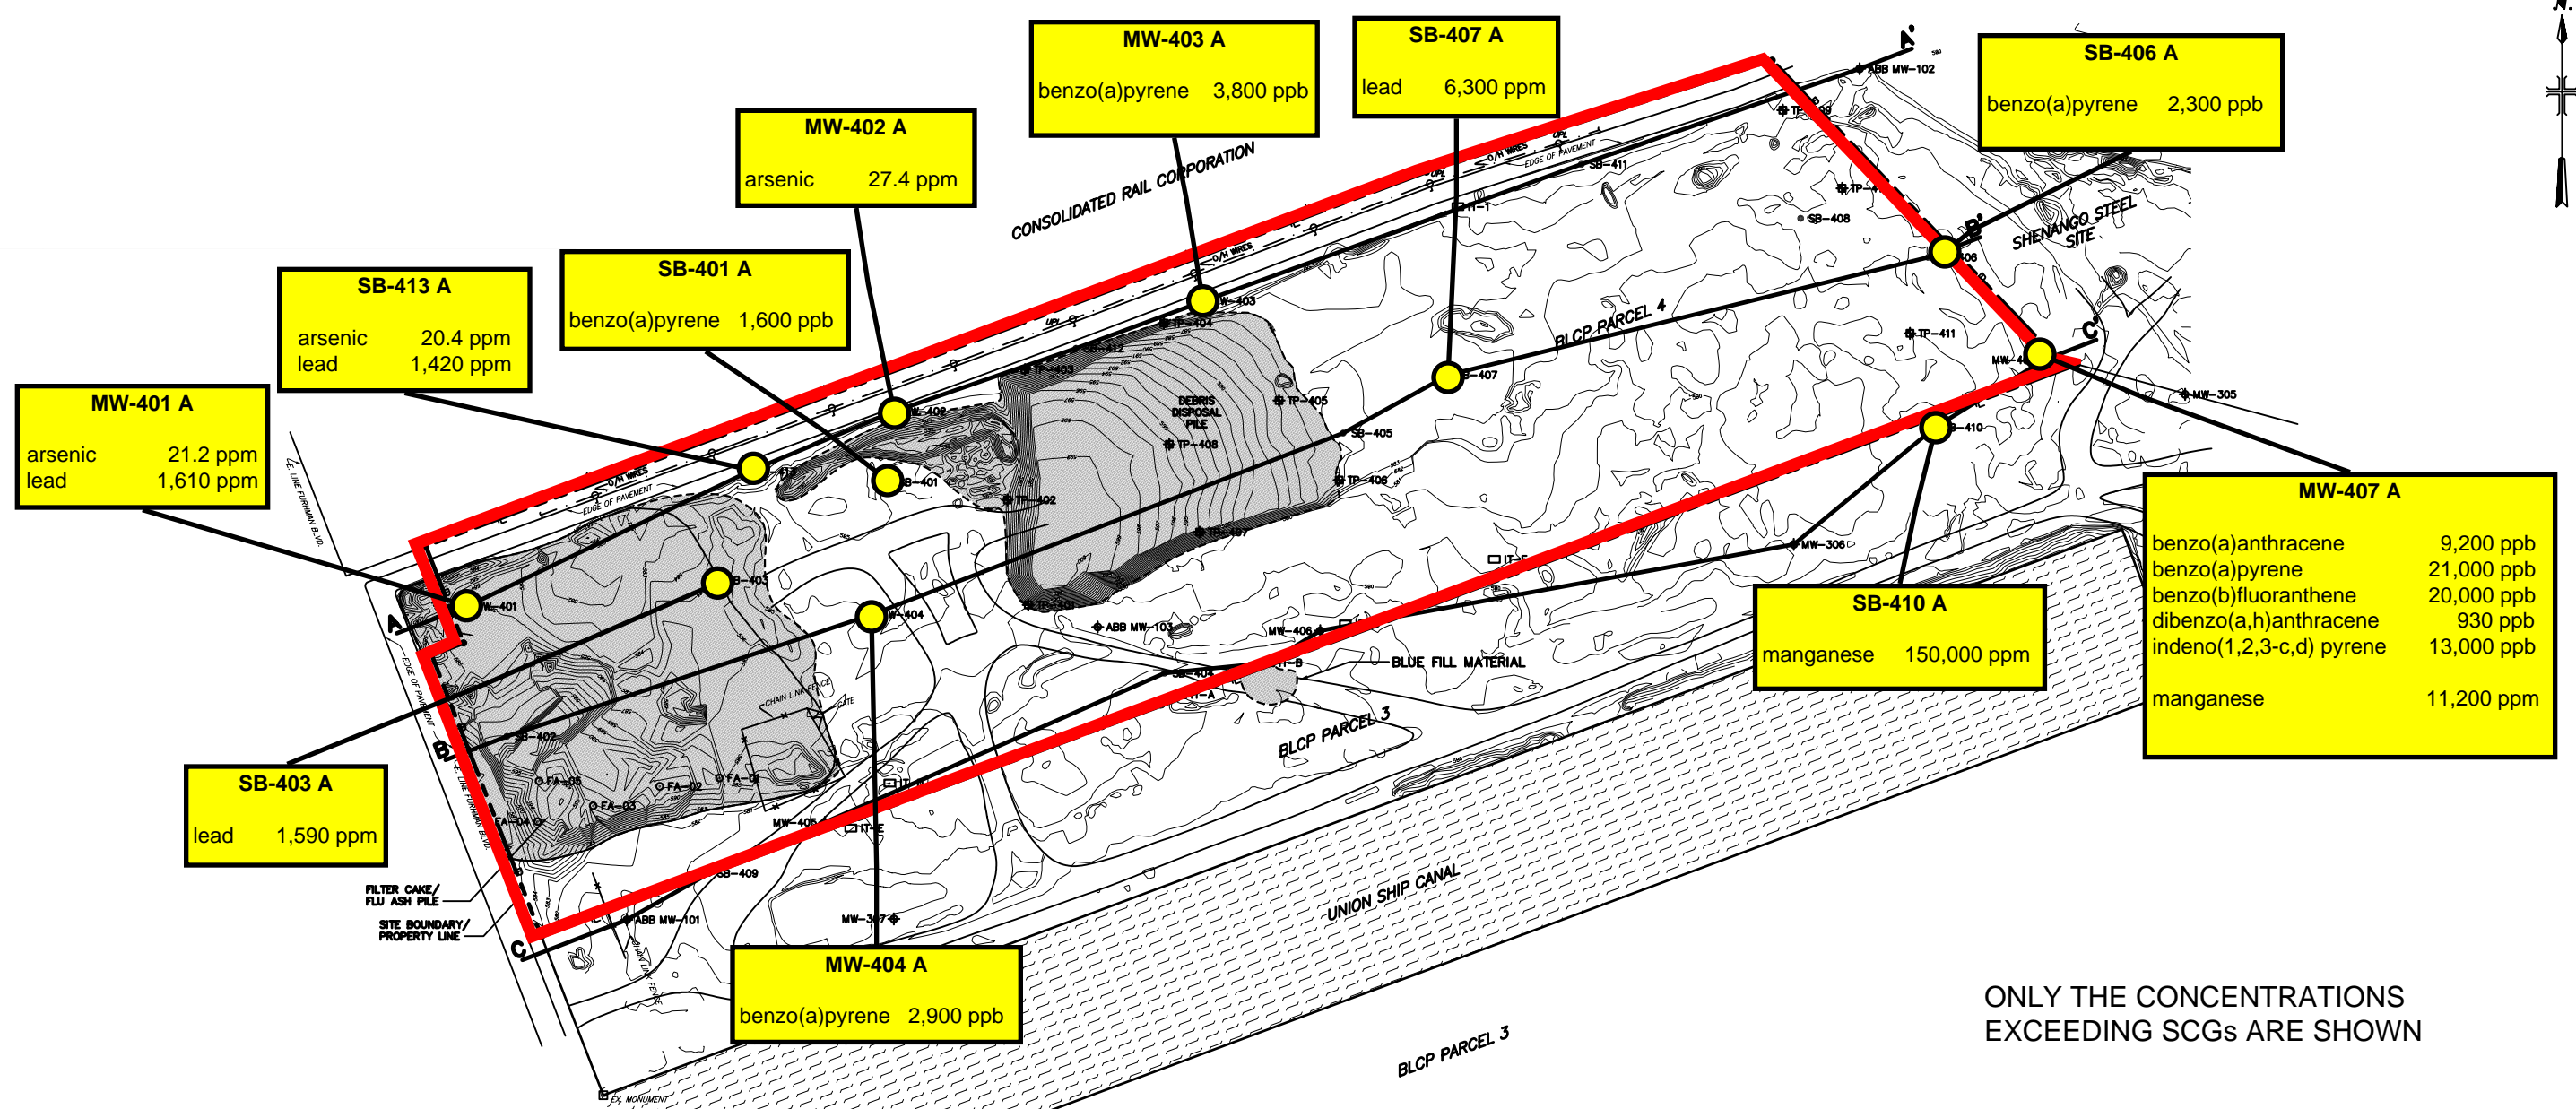
**FIGURE 3  
ANALYTICAL RESULTS  
SURFACE SOIL/FILL**

ONLY THE CONCENTRATIONS EXCEEDING SCGs ARE SHOWN

Seven PAHs were present in surface soil/fill at the Site at concentrations in excess of the 6 NYCRR Subpart 375-6 SCOs for unrestricted use in seven of the twenty surface soil/fill samples collected. Only five of these PAHs were present at levels in excess of the SCOs for restricted commercial use. All five of these PAHs are known carcinogenic PAHs, however, only one of these, benzo(a)pyrene, was present above the typical range found in urban soils. All other PAHs detected were within or below the typical urban background concentrations for PAHs.

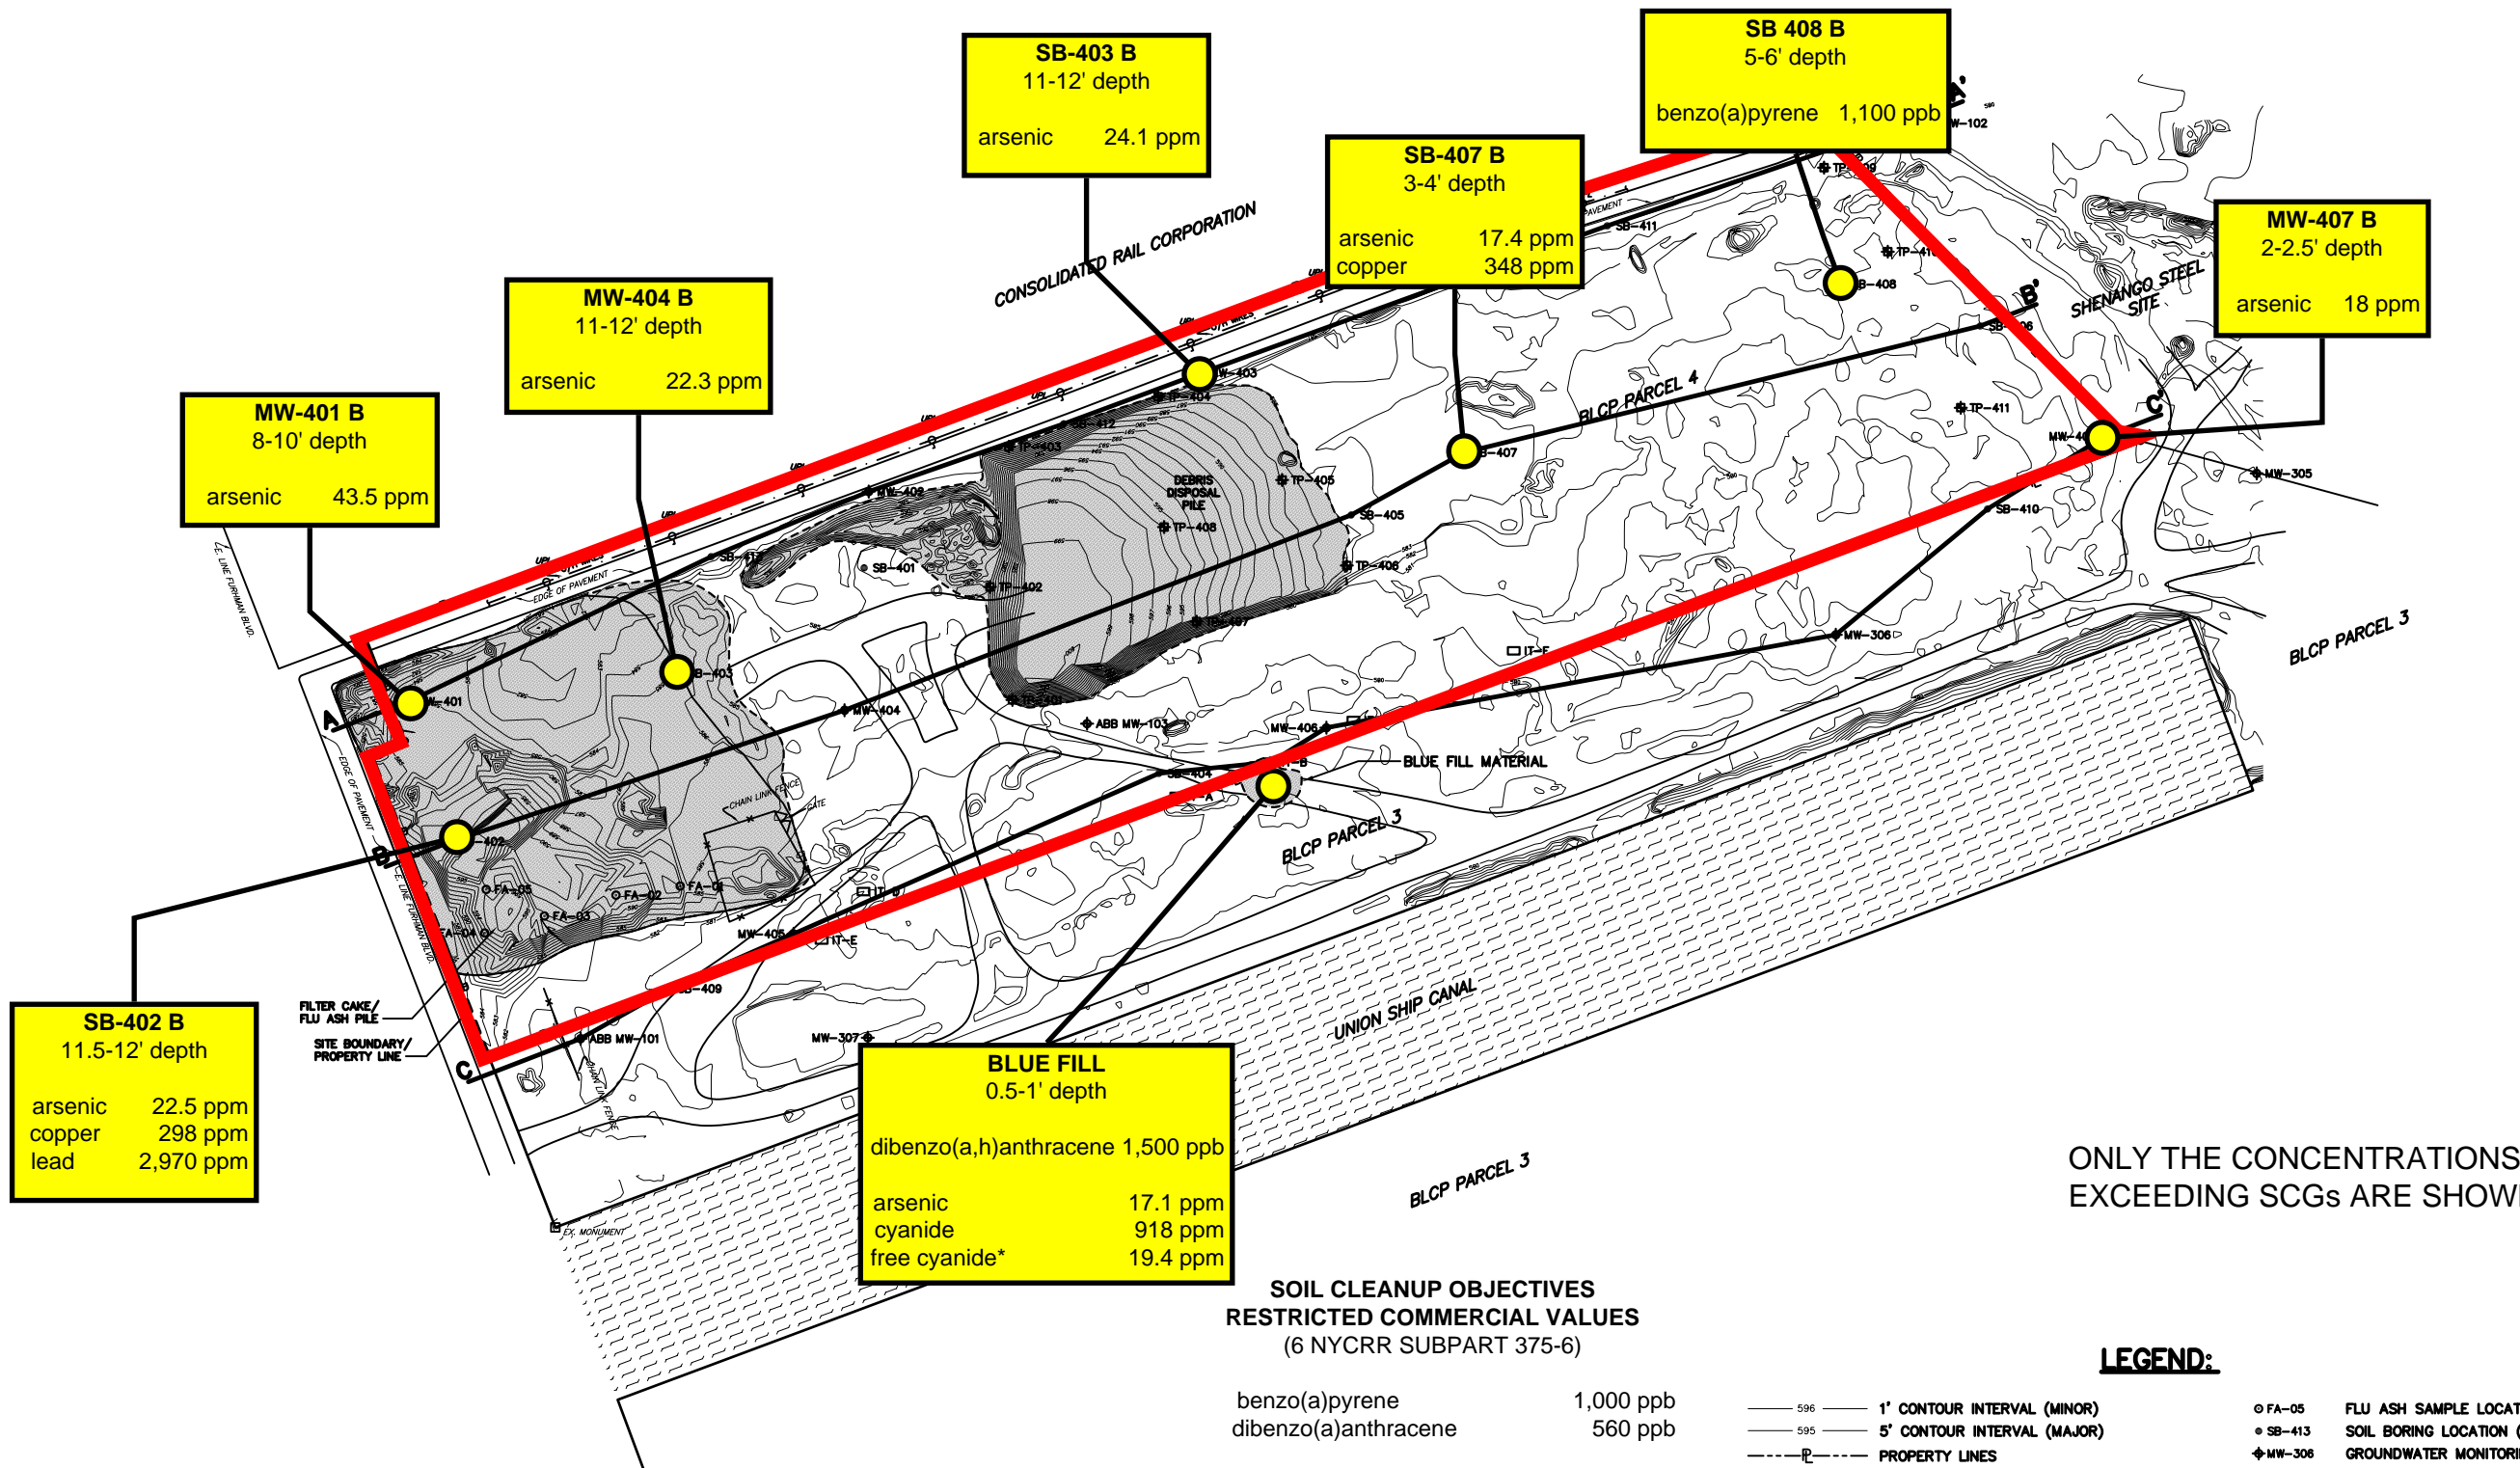
**FIGURE 4  
ANALYTICAL RESULTS  
SUB-SURFACE SOIL/FILL**

**SB-402 B**  
11.5-12' depth

arsenic	22.5 ppm
copper	298 ppm
lead	2,970 ppm

Only one sample, SB-408B (5'-6') contained PAHs above the SCOs for unrestricted use. The two PAHs found, benzo(a)pyrene and benzo(b)fluoranthene, are known carcinogens. Only benzo(a)pyrene was detected at a concentration exceeding its SCO for restricted commercial site use; 1100 ppb was found, which is slightly above the SCO of 1000 ppb.

Arsenic, copper, and lead were detected in one or more samples at concentrations above but within the same order of magnitude of the respective SCOs. The samples containing metals at concentrations in excess of SCOs and eastern United States background concentrations were generally well distributed across the Site with no one concentrated area of contamination observed. Sample SB-402B was one notable exception; lead was detected at a concentration of 2,970 ppm, which was higher than most other samples and above the 63 ppm and 1,000 ppm SCOs for unrestricted and restricted commercial use respectively. Subsurface soil contamination identified during the SI/RAR will be addressed in the remedy selection process.

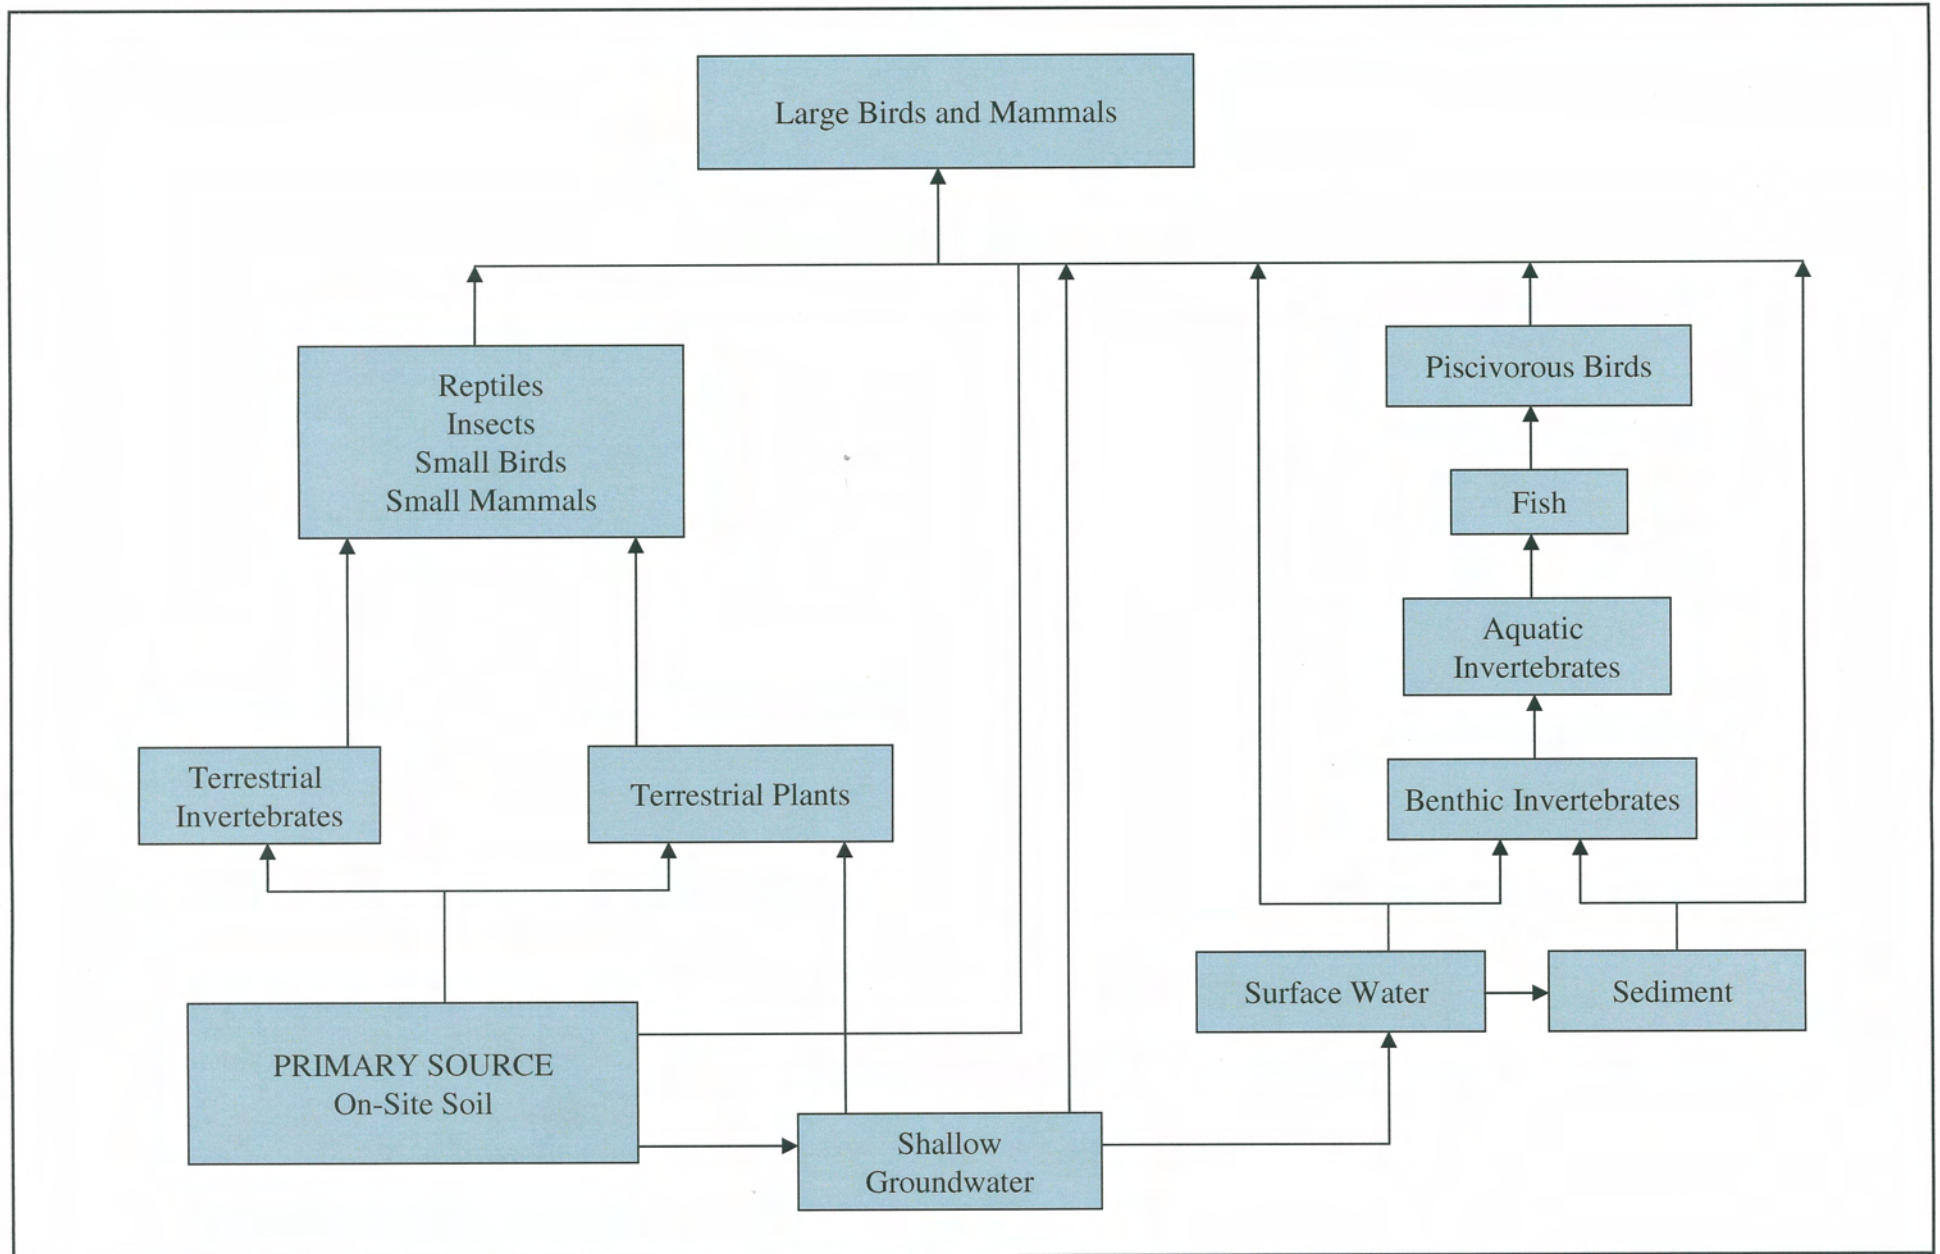
**FIGURE 6**

**CONCEPTUAL SITE MODEL**  
 Buffalo Lakeside Commerce Park, Parcel 4  
 Buffalo, New York
